Id 37759

Models LS - Range Rover Sport

Title Tyre tread pattern - Continental 4x4 Sport Contact tyres

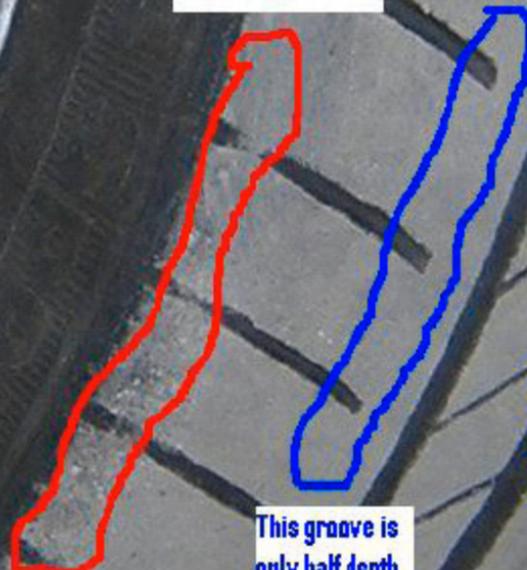
With reference to the photo attached, Due to the tread pattern design of this tyre, there can appear to be inner or outer shoulder wear. This is in fact just the natural tread wear, but as the design of the lateral grooves continues around to the sidewall, the very ends of the grooves do not wear giving rise to a "band" of wear at the edge of the contact patch.

Cosmetic effect only

This groove is only half depth to start with, so disappears when tyre half worn

Tread wear indicators - 1.5mm left when the tread wears down to the top. Uneven wear should be measured against those.

Where applicable please review this SSM before carrying out tyre replacement or geometry adjustment under warranty as no action is required for this issue. It is deemed a characteristic of the tyre and not a fault.
