# Technical Service Bulletin

No.LTB00204v3  
22 May 2009

<b>Subject/Concern:</b>	Front Suspension Knock (Straight Ahead) – Vehicles With Dynamic Response Only
-------------------------	---

<b>Models:</b>	
Range Rover Sport (LS)	VIN-range: 6A900290-9A211334

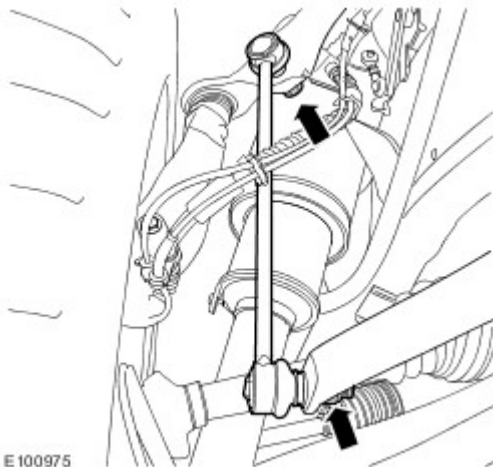
- 1 . Remove engine undershield (see Global Technical Reference GTR Workshop Manual, section 501-02).
- 2 . Check torque of stabilizer bar link (upper and lower) fixings.

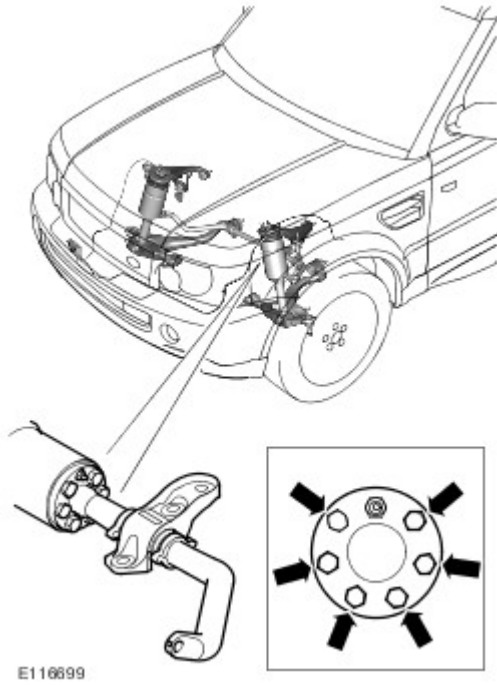
- 3 . Check torque of actuator arm flange bolts to actuator body.

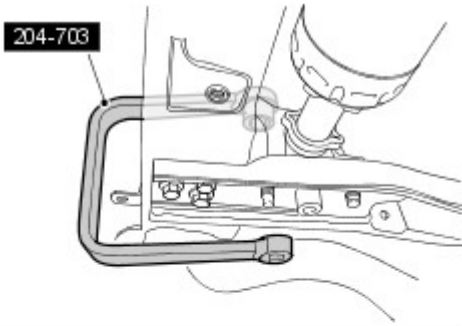
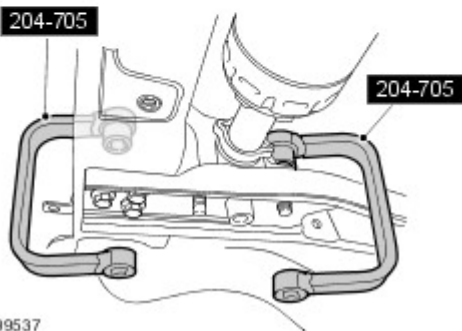
- 4 . Check all associated pipe routing, ensure no inadvertent pipe to frame/body contact is evident. Clear stones and contamination from pipes and shields (these are the main recognized routes for increased system noise transfer).
- 5 . Using special tools 204-703 and 204-705, check torque of front actuator clamp fixings.

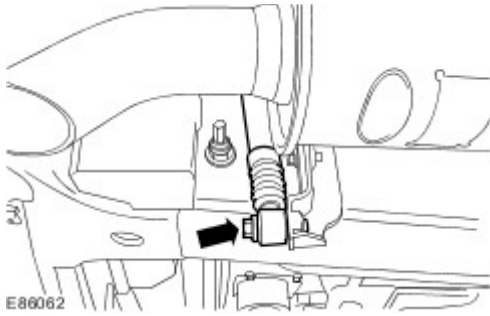
- 6 . Install engine undershield (see Global Technical Reference GTR Workshop Manual, section 501-02).
  - 7 . **NOTE:** If the knock is still evident, carry on from step 8.
- Carry out a five minute road test over a rough surface.
- 8 . **NOTE:** Checking the function of the rear body mount dampers. Rear right-hand bottom fixing shown, top fixing similar. Left-hand rear body mount damper similar.

Remove both rear body mount dampers.

If the knock has improved or been eliminated, replace the rear body dampers as appropriate. If knock still apparent, reinstall the original dampers.

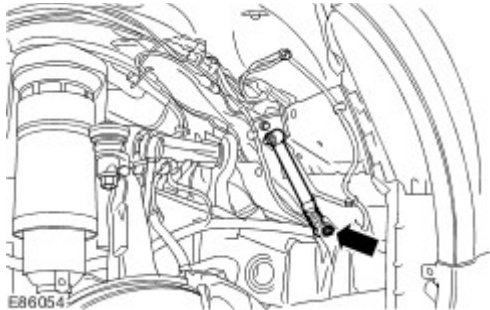
11 . **NOTE:** Front left-hand bottom body mount damper fixing shown, top fixing similar. Right-hand front body mount damper similar.

Remove both front body mount dampers.

12 . **NOTE:** If the knock has been eliminated at step 11, return the vehicle to the customer without refitting the front dampers. It is not necessary to install front body mount dampers on dynamic Response equipped vehicles. If the knock is still evident, carry on from step 13.
