Technical Service Bulletin

No.LTB00006V2
10 January 2007

Subject/Concern : Liftgate Noise

Models :
Range Rover Sport (LS) | | VIN- range : 6A956500-6A975601

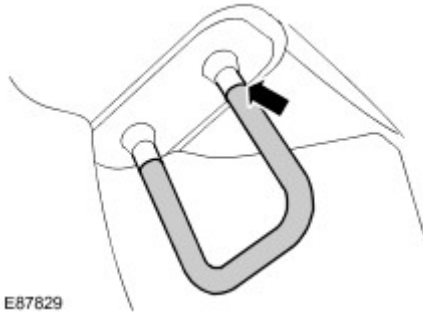
- 1 . If the striker has a black plastic coating on the striker loop as illustrated, the striker is to the correct specification. The striker loop may not be the root cause of the noise and further diagnosis may be required.

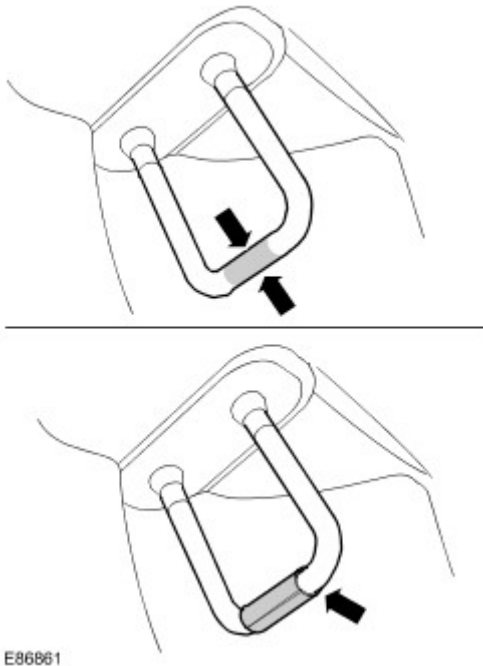
Cause : On some vehicles, the liftgate window glass has been installed with a striker loop that has not been plastic coated. This could result in the closed catch assembly being the cause of the above noise.

Apply adhesive from the service kit along approximately 20mm of the lower part of the striker loop, ensuring coverage around the complete circumference.

Using a nylon sleeve from the service kit, open out the sleeve and position over the lower part of the striker loop where the glue is applied (refer to illustration above).
