Technical Service Bulletin

No.LTB00097

Subject/Concern: Discovery 3/LR3, Range Rover Sport - Minor Steering Column Knock
--

Models:		
Discovery 3 / LR3		VIN-range: 000303-444606
Range Rover Sport (LS)		VIN-range: 900109-122778

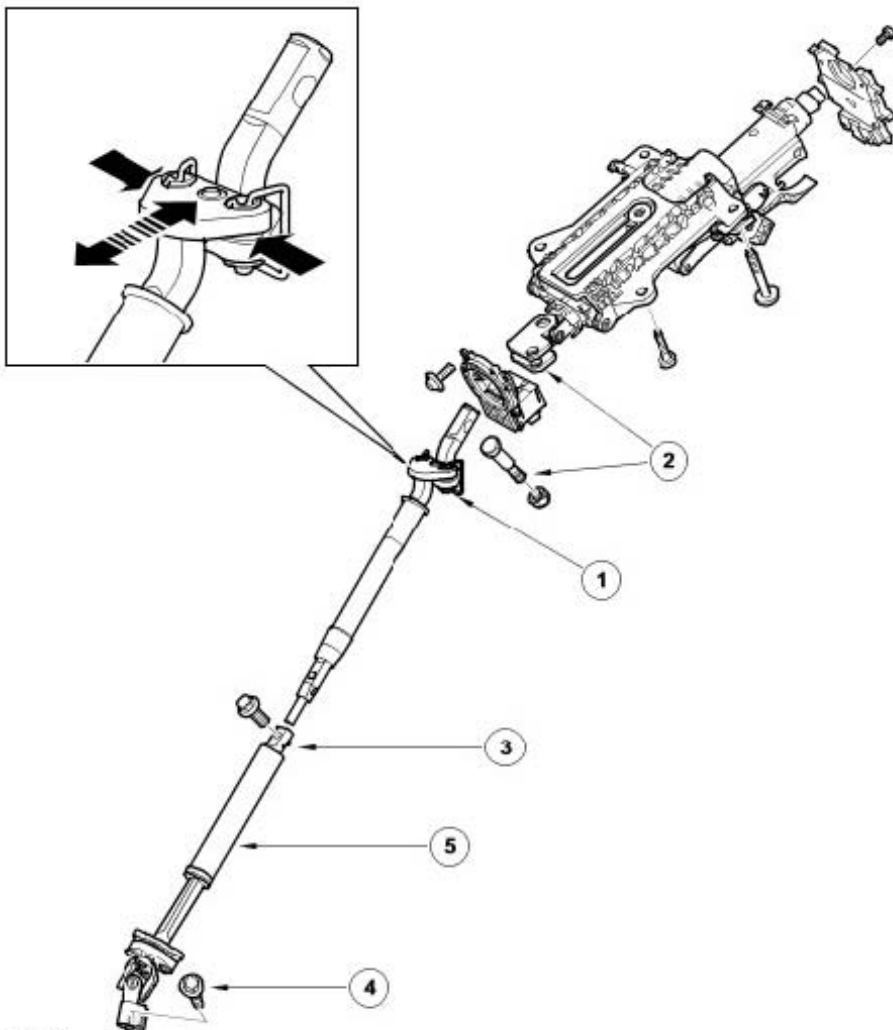
Cause: Dynamic movement in the lower steering shaft sliding joint due to low sliding loads. **Suggested Customer Concern Code - N58.**

- 1 Examine the steering column intermediate shaft 'decoupler' (item 1 in illustration) integrity, ensuring that the steel and rubber washers are correctly located. 1 . If excessive movement exists at the decoupler or the washers are not correctly located, renew the intermediate shaft.

- 2 Check the steering column universal joint to upper intermediate shaft connection (item 2 in illustration) retaining torque; 30Nm (22lb-ft).
- 3 Check for movement at the intermediate to lower shaft joint (item 3 in illustration). 1 If movement exists, renew the bolt and tighten to 30Nm (22lb-ft).

- 4 .
4 Check for movement at the lower shaft universal joint to steering gear connection (item 4 in illustration). 1 If movement exists, renew the retaining bolt and tighten to 30Nm (22lb-ft).

- 5 . Check for movement at the lower shaft sliding joint (item 5 in illustration).
1 If movement exists, renew the lower shaft.
