16 August 2005

Models:		
Range Rover Sport (LS)

VIN-range: 5A900500 Onwards

## Markets: All Section: 501-08

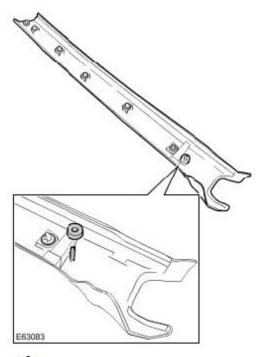
2 . Remove and discard the foam washer from the lower peg.

CAUTION: Ensure any remaining protrusions will not contact the body A-pillar.

3 .Cut away the lower location peg from the A-pillar trim.
