TECHNICAL BULLETIN

No: SB034-SB036

SERVICE ACTION: Vehicle Enhancement Program

COMBINED REPAIR PROCESS TO ENHANCE ALL VEHICLES

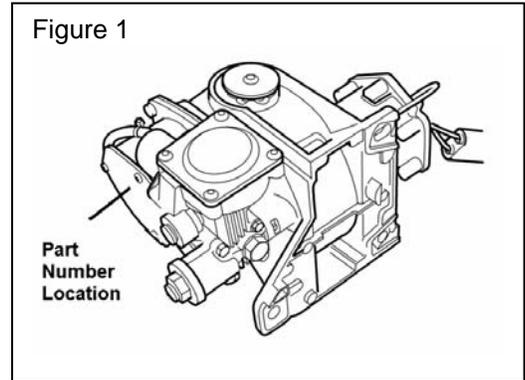
1. Locate the air suspension compressor mounted on the left side frame rail and inspect the crank case end plate for the part number. (Figure 1)
2. Refer to the table below and determine the action required from the observed compressor part number.

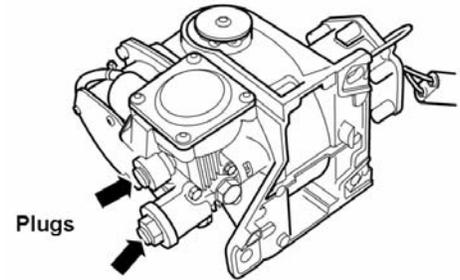
Figure 2

4. Install plugs to the open connections of the inlet and outlet pipes of the compressor being inspected and clean the compressor assembly. (Figure 2)
5. Undo and remove the delivery valve-retaining plug: (Figure 3)

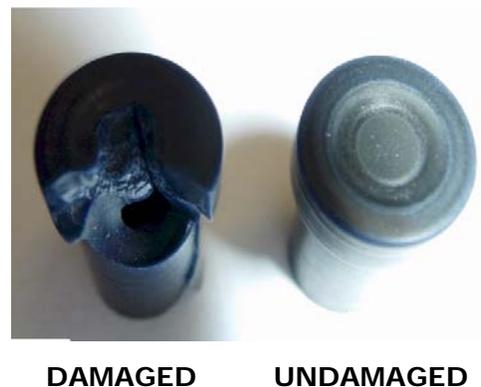
Figure 4

- Remove and discard the retaining plug O-ring seal.
 - Remove the return spring and the delivery valve and discard the spring.
 - Inspect the delivery valve for damage (Figure 4)

- If the delivery valve is damaged (left image in Figure 4) replace the air compressor with a new unit following GTR section 60.50.10 procedures.
 - If the delivery valve is **not** damaged, (right image in Figure 4) perform the Compressor Repair Procedure that follows.

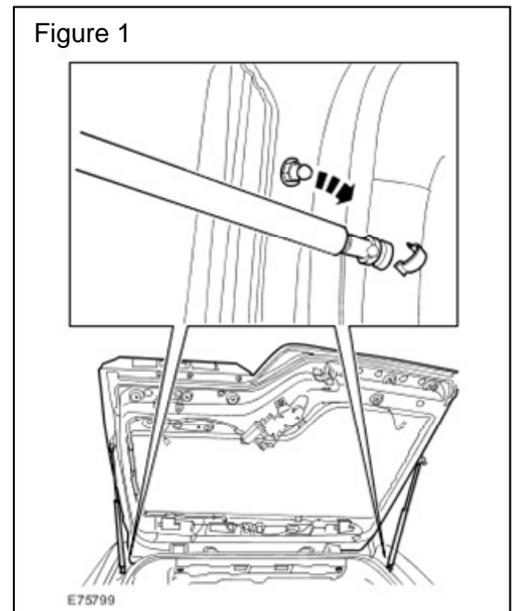
Figure 1

UPPER TAILGATE SUPPORT BALL STUD RATTLE REPAIR

1. Release the upper tailgate support strut from the D-pillar ball stud. (Figure 1)
2. Remove the ball stud assembly from the body.
3. Apply liquid thread-lock (STC50552/Loctite 242) to the ball spigot thread.
4. Install the ball spigot.
5. Tighten to **23Nm (17 lbf.ft)**.
6. Install the upper tailgate support.
