# TECHNICAL BULLETIN

No: LTB00034  
Issue: 1  
Date: 01 Mar 2007

**SECTION: 501-00 – BODY – GENERAL INFORMATION**

## Passenger Compartment Water Ingress

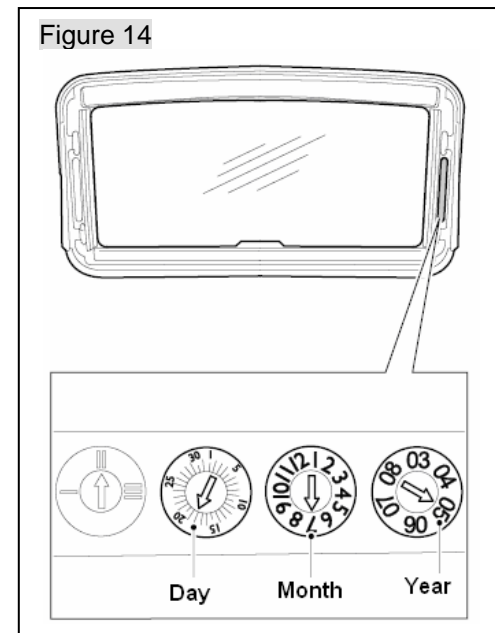
**NOTE:** If a customer reports water ingress during the use of a machine car wash and the vehicle was built prior to VIN 6A922812 the glass panel assembly bracket may prevent insufficient travel to meet alignment specifications, and the roof opening panel glass assembly may require replacement.

**NOTE:** The glass panel assembly production date is determined from the 'Day', 'Month' and 'Year' indicated by the arrows in each of the three dials as illustrated in Figure 14. As an example, the arrows depicted in Figure 14 indicate 18\_7\_05, a production date of 18-July-2005.

1. Verify the glass panel assembly production date indicated by each of the three arrows located on the assembly. (Figure 14)
2. If the production date indicated by the dials is prior to 1\_10\_05 (01-Oct-2005), refer to GTR Section 76.84.03 and replace the roof opening panel glass with part number EFT500032.
