SERVICE ACTION

Service Action Number:
Q079

Subject: Suspension Ride Height Sensors – Corrosion and Air Suspension Ride Levelling Control Module (RLM) Software Update	Publication No.:	204-Q079v2
	Model:	Discovery 3
	Model Year:	2008 – 2009
	VIN Range:	LA461580 – LA513324
	Model:	Range Rover Sport
	Model Year:	2008 – 2009
	VIN Range:	LS144333 – LS215577
	Date of Issue:	28 January 2010
Expiry Date:	31 January 2012

RE: Ride Height Sensors – Corrosion and Suspension RLM Software Update

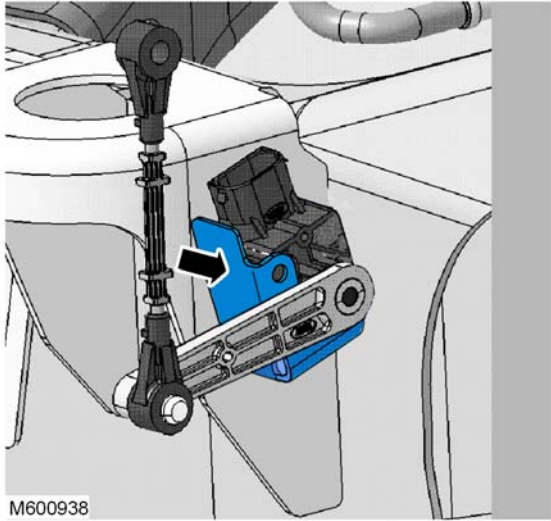
<p>M600938</p>
<p style="text-align: right;">Fig. 1</p>		
<p>2</p>	<p>CAUTION:

<p>1</p>	<p>Note: Left-hand side shown, right-hand side similar.</p> <p>Inspect ride height sensor bracket position for orientation (see Fig. 1).</p>

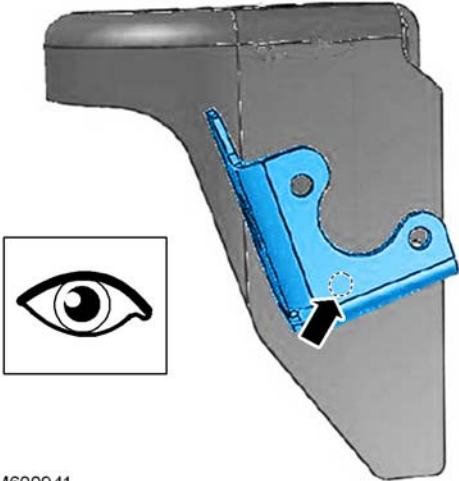
<p>M600941</p>
<p style="text-align: right;">Fig. 2</p>

The bracket shown in figure 2 may have 2 or 3 holes. It is important that the orientation of the bracket is noted and not the number of holes.</p> <p>NOTE: The position of the ride height sensor electrical connector remains the same for both original and new sensors.</p> <p>If the orientation of the left-hand rear ride height sensor bracket is the same as figure 2, carry on to step 5, if not carry on from step 3.</p>

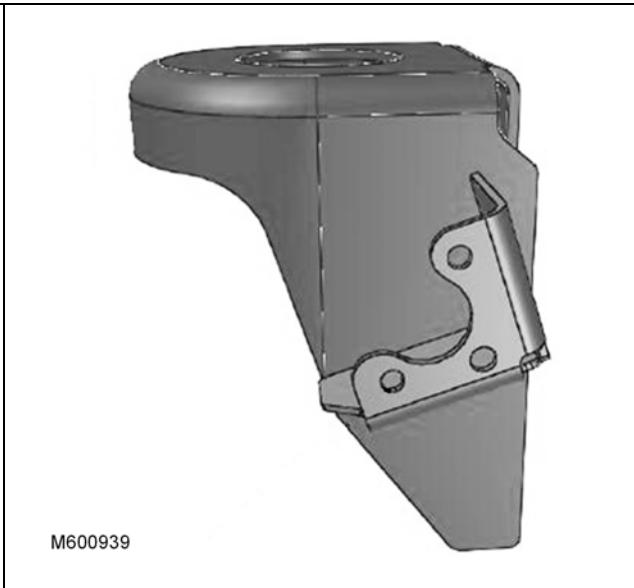
Fig. 3

3 **Note: This condition only affects a small number of chassis frames of vehicles built at the end of 2009.**
 If the ride height sensor bracket is installed as shown in Fig. 3, carry on from step 4.
