TECHNICAL BULLETIN

No: LA-501-006

A-pillar Water Leak

Land Rover LR3 (LA)

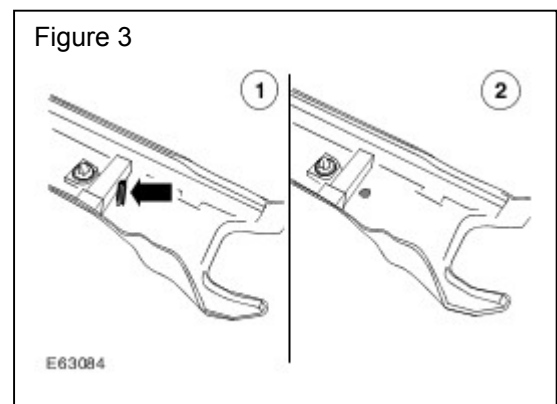
△ **NOTE:** The lower peg must be cut flush with the surface of the trim piece to ensure no protrusion will interfere with the A-pillar bodywork or the newly installed seal.

5. Cut the lower location peg from the A-pillar trim. (Figure 3)
