TECHNICAL BULLETIN

No: LTB00034
Issue: 2
Date: 20 MAY 2010

Passenger Compartment Water Ingress

Range Rover Sport (LS)

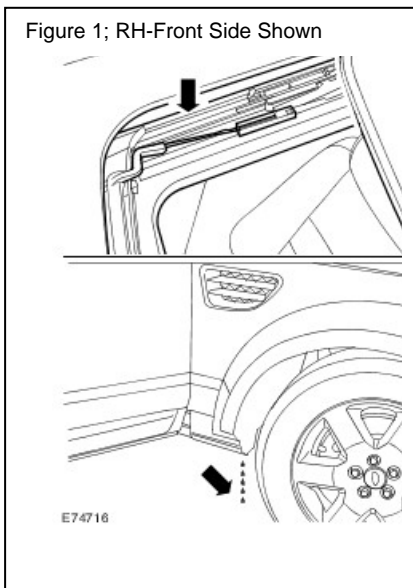
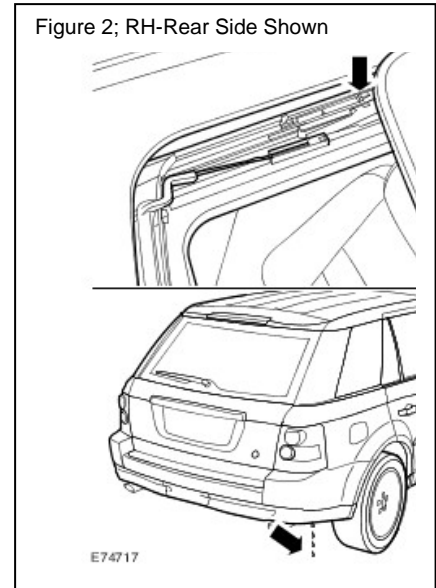
- Place the vehicle on dry level ground.
- Fully open the sunroof panel to gain access to the water trap.
- Carefully pour water into the water traps, one corner at a time so that the water drains into the drain hole and drain hose. (Figures 1 and 2)
- Confirm that water has pooled on the ground at all four drain points under the A-pillar and D-pillar on both sides of the vehicle. (Figures 1 and 2)

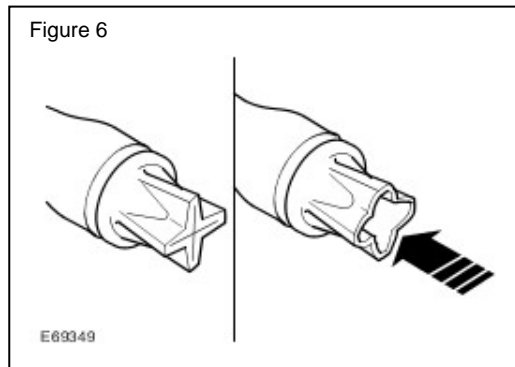
Figure 6

5. If the tube is not protruding through the hole in the body perform the following steps to correctly position the roof opening panel drain tube:
 - Refer to Workshop Manual (GTR) Section 501-05, *Interior Trim and Ornamentation (76.13.27)*, and remove the cowl side trim panel to gain access to the roof opening panel drain tube.
 - Connect and secure the drain tube through the hole.
 - Verify the valve of the roof opening panel drain tube can be fully opened. (Figure 6)
 - If the valve can not be opened, cut as required to permit full opening. (Figure 6)
 - Install cowl side trim panel

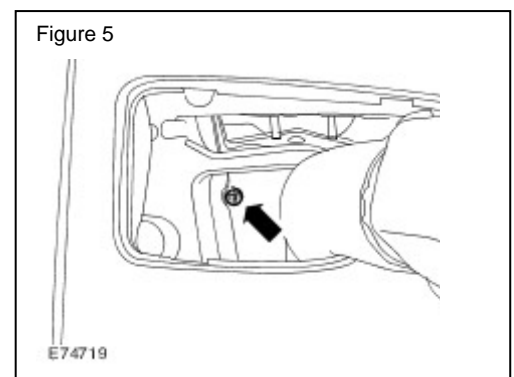
Figure 5

NOTE: If both the routing of the roof opening panel drain tube is correct and the valve of the roof opening panel drain tube cannot be faulted, the foam insulation pad may be the cause. The foam sound-deadening pad may have been installed in such a way as to block the roof opening panel drain tube end.

1. Remove the fender air intake grill by first pulling up to release the two lower clips and then pulling down and outward to release the two upper clips. (Figure 3)
2. Move the air duct aside. (Figure 4)
3. Release the foam insulation pad to gain access to the roof opening panel drain tube end. (Figure 4)
4. Verify that the drain tube is protruding through the hole in the body. (Figure 5)

6. Remove and then install the foam sound-deadening pad, taking care to ensure that the roof opening panel drain tube valve locates in the indent in the foam insulation pad to avoid crimping the tube.

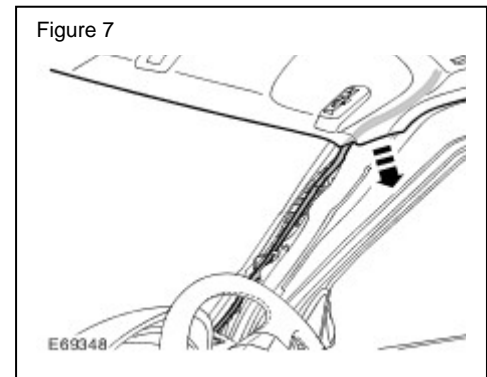
11. Inspect for misrouting or kinking of the roof opening panel drain tube paying particular attention to :
 - Collapsed elbow joints
 - Pinched tube
 - Inclined routing

9. If satisfactory test is NOT completed, blow out the drain tube with compressed air and test again.
10. If satisfactory test is still NOT completed, refer to Workshop Manual (GTR) Section 501-05, *Interior Trim and Ornamentation* (76.13.27), and remove the headliner to gain access to the drain tube. (Figure 7)

12. Repair drain tube routing as necessary and confirm free-flow of water by repeating the **TEST SUNROOF DRAINS** procedure.
13. If satisfactory test is completed, install the headliner.

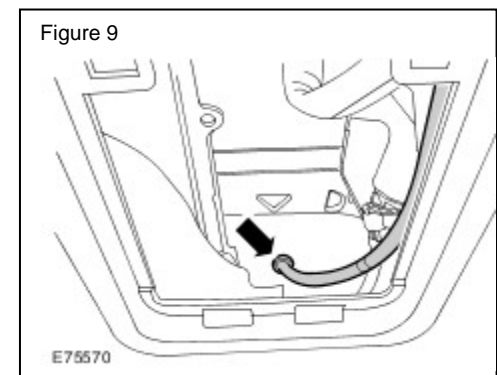
NOTE: This procedure should be followed if there is no water is found pooling on the ground below the right-hand side D-pillar during testing.

1. Open the right-hand side access flap in the tailgate load space to gain access to the roof opening panel drain tube. (Figure 9)
2. Verify that the roof opening panel drain tube is protruding through the hole in the body.

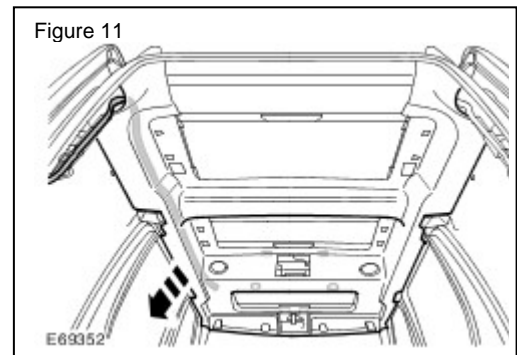
9. Inspect for misrouting or kinking of the roof opening panel drain tube, paying particular attention to:
 - Collapsed elbow joints
 - Pinched tube
 - Inclined routing

8. If the concern has still NOT been corrected refer to Workshop Manual (GTR) Section 501-05, *Interior Trim and Ornamentation* (76.64.15), and remove the headliner to gain access to the drain tube. (Figure 11)

10. Repair drain tube routing as necessary and retest.
11. If satisfactory test completed, install the headliner.
12. Install the left-hand side rear quarter trim panel.

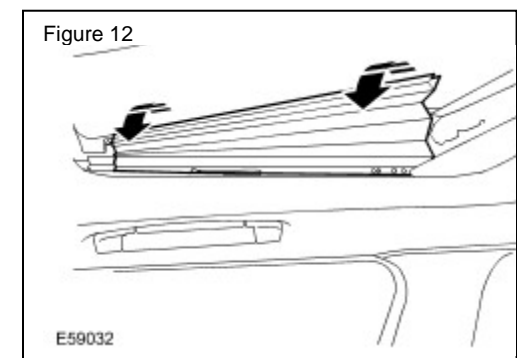
NOTE: When all of the drain tubes are confirmed as functioning correctly the roof opening panel glass alignment can be tested as a leak source.

1. Open the roof opening panel blind, leaving the roof opening panel closed.
2. Verify that the glass panel is centered in its opening.
3. Verify that the front edge is set flush or up to 1.0 mm (0.040 in) below the roof line.
4. Verify that the rear edge is set flush or up to 1.0 mm (0.040 in) higher than the roof line.
5. From inside the vehicle, remove the roof opening panel mechanism covers. (Figure 12)

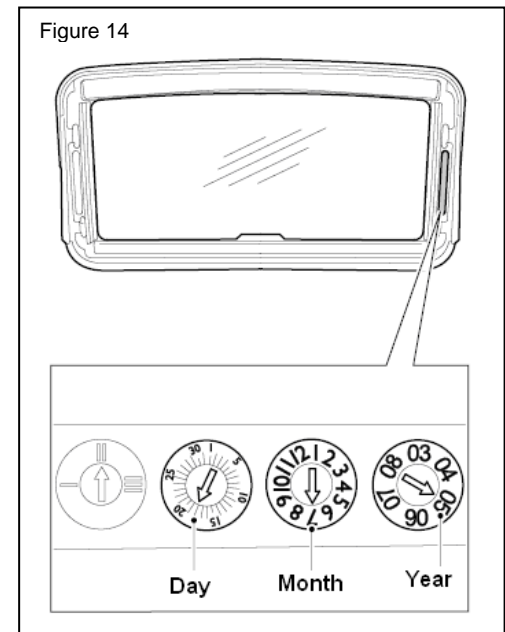
NOTE: If a customer reports water ingress during the use of a machine car wash and the vehicle was built prior to VIN 6A922812 the glass panel assembly bracket may prevent insufficient travel to meet alignment specifications, and the roof opening panel glass assembly may require replacement.

NOTE: The glass panel assembly production date is determined from the 'Day_Month_Year' indicated by the arrows in each of the three dials as illustrated in Figure 14.
Example: the arrows depicted in Figure 14 indicate '18_7_05' - a production date of '18-July-2005'.

1. Verify the glass panel assembly production date indicated by each of the three arrows located on the assembly. (Figure 14)
2. If the production date indicated by the dials is prior to '1_10_05' (01-Oct-2005), refer to Workshop Manual (GTR) Section 501-05, *Interior Trim and Ornamentation* (76.84.03), and replace the roof opening panel glass with part number **EFT500032**.
