TECHNICAL BULLETIN

No: LTB00202
Issue: 1
Date: 09 FEB 2009

Navigation System Routing Errors - Repair Procedure

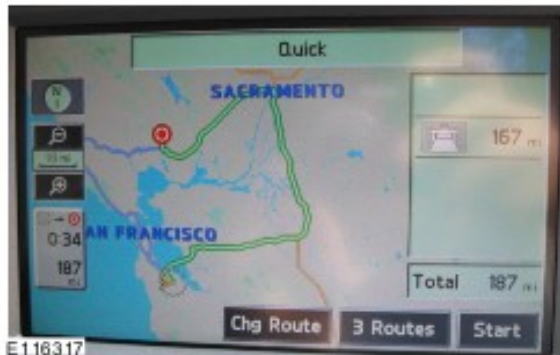
Figure 1 - Incorrect Route

NOTE: The routing error shown has only been reported in the San Francisco, CA and Seattle, WA regions. If the error shown is similar in Canada or other regions of the USA, submit an EPQR or contact the Land Rover Technical HelpLine.

1. After entering destination, suggested navigation route significantly longer than expected. (Figure 1)
2. Expected routes. (Figure 2)

1. Switch ignition 'ON'.
2. Remove Navigation system DVD.
3. Verify DVD part number:
 - If the DVD part number is 6H42-10E898-BB, continue to step 4.
 - If the DVD part number is not 6H42-10E898-BB, verify the Navigation system routing preferences / settings and contact the Land Rover Technical HelpLine if necessary.

4. Install new Navigation DVD, allowing the Navigation module to update.
5. Once the Navigation system displays the disclaimer screen, switch the ignition 'OFF'.

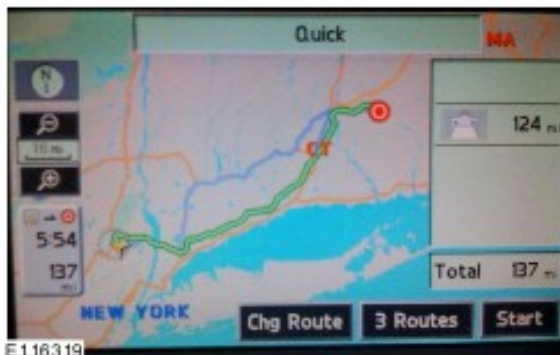
Figure 3

NOTE: The routing error shown has only been reported in the north-eastern region the USA. If the error shown is similar in Canada or other regions of the USA, submit an EPQR or contact the Land Rover Technical HelpLine.

3. Navigation system does not display city entered. (Figure 3)
4. City entered displayed / route as expected. (Figure 4)
