Technical Service Bulletin

No.LTB00030v2
15 February 2007

Subject/Concern: Steering Wheel Vibration/Steering Shimmy
--

Range Rover Sport (LS)		VIN-range: 5A900018 Onwards
Range Rover (LM)		VIN-range: 2A100003-5A198056

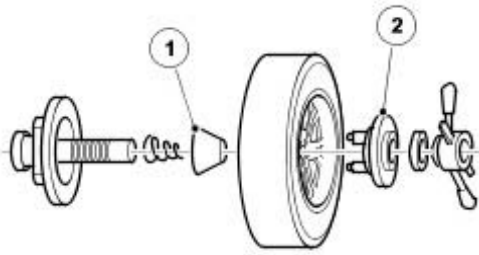
E83696

Balance road wheel and tire assemblies until the residual imbalance dynamic is minimized. Target is 0g on each plane, maximum is inner 5g, outer 5g.

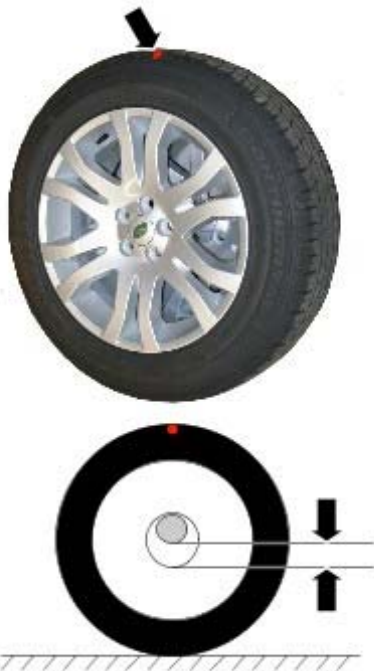
E83695

14 . Assess the level of wheel vibration:

1 If acceptable, no further action is required.

2 If the levels of vibration remain unacceptable, continue to next step.
