TECHNICAL BULLETIN

No: LTB00041
Issue: 2
Date: 24 May 2007

Reduced Power Under Load Possible DTC P0096 and/or P2601 Stored

Range Rover (LM) Supercharged	6A198058 to 7A261419
Range Rover Sport (LS) Supercharged	6A901924 to 7A109767

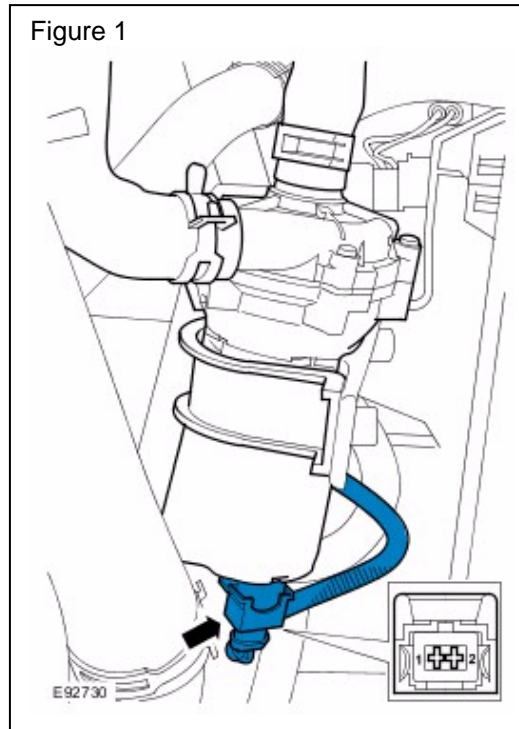
Situation: The customer may complain of reduced power and or a misfire at high engine loads and road speeds, with the possibility of Diagnostic Trouble Codes (DTC) P0096 and/or P2601 stored. The electrical harness power supply and ground for the auxiliary coolant pump may be cross connected in connector C3006. The pump will run backwards causing the Engine Control Module (ECM) to reduce power to prevent damage because the pump flow is low. The auxiliary coolant pump will be degraded under these conditions.

1. Release the connector locking tab and disconnect connector C3006 from the coolant pump (Figure 1)

2. Inspect the wires to determine if they are crossed.

- Black (B) wire in Cavity 1 connected to "-" pump connection
- Brown and Purple (NP) wire in Cavity 2 connected to "+" pump connection

- Brown (N) wire in Cavity 1 connected to "-" pump connection
- Red and White (RW) wire in Cavity 2 connected to "+" pump connection

3. If the wires are crossed, use terminal extractor tool YRW9000010 from the Harness Repair Kit and swap cavity 1 and cavity 2 wires to the positions indicated above.

6. If the wires were crossed in connector C3006 or the fault codes P0096 or P2601 are stored, refer to GTR section: 303-03D (26.50.26) and install a new supercharger coolant pump.
7. If the coolant pump is replaced, perform a final IDS check as follows:
 - Connect the battery charger and re-connect the VCM to continue the session.
 - Use IDS, following the on-screen instructions, to clear DTCs.
 - When the task is completed, exit the current session.
8. Disconnect IDS and the battery charger/power supply.
