Technical Service Bulletin

No.LTB00123 18 March 2008

Subject/Concern: Front Suspension Knock Diagnosis

Models:	
Discovery 3 / LR3	VIN-range: 000360 Onwards
Range Rover Sport (LS)	VIN-range: 900290 Onwards

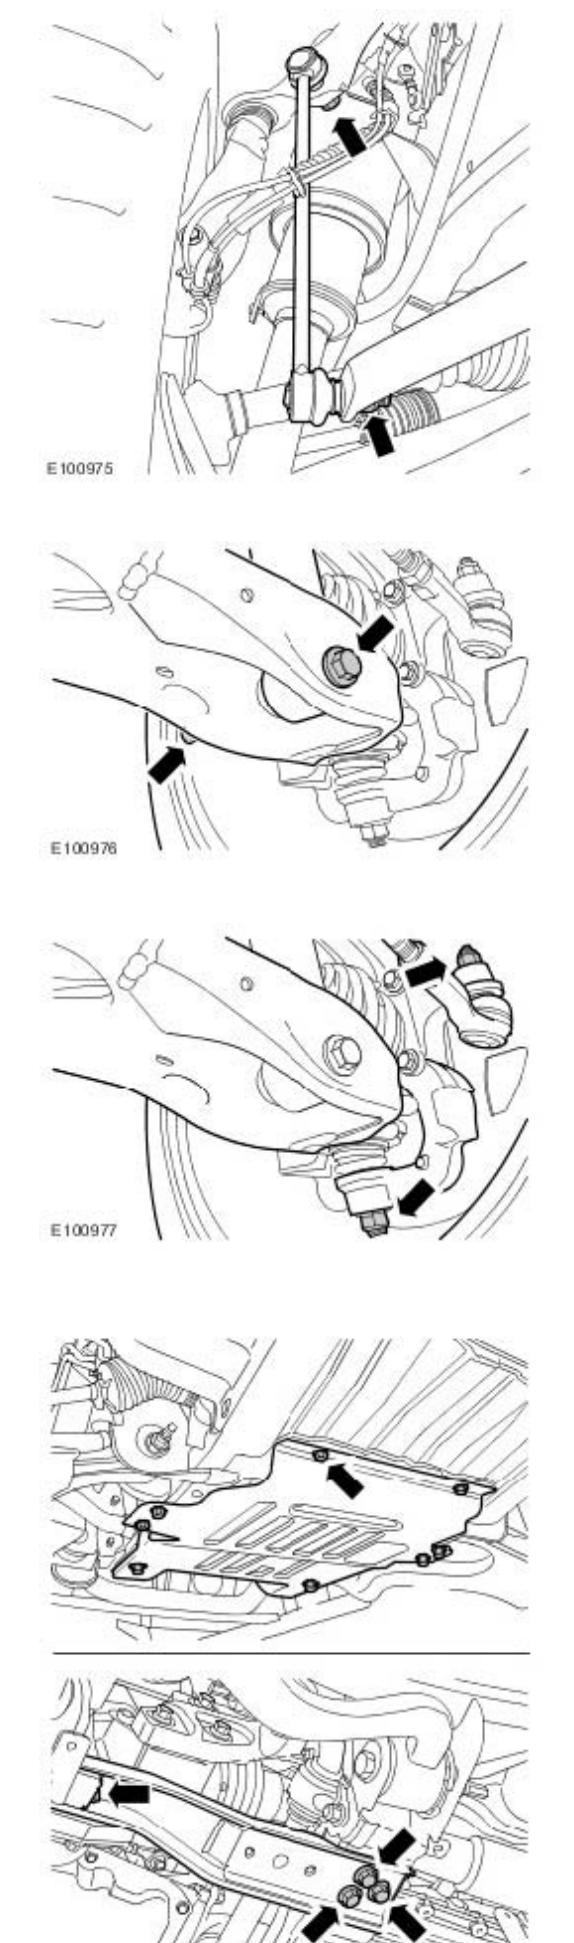
E100978

Check torque of stabilizer bar stabilizer link fixings (upper & lower).

2 . Check torque of damper lower fixing and bushing.

3 . Check torques of control lower arm ball joint nuts and steering gear tie rod end nuts.

4 . Check torque of front differential cross member and undertray fixings.

5. Check torque of front upper suspension arm forward and rear bushing fixings (if torque-tightening is necessary this must be carried out at the correct ride height to prevent preloading of bushings).

6. Check torque of front lower suspension arm forward and rear bushing fixings (if torque-tightening is necessary this must be carried out at the correct ride height to prevent preloading of bushings).

7 . On vehicles not fitted with Dynamic Response, check torque of stabilizer bar clamp fixings.

8 . On vehicles fitted with Dynamic Response, check front actuator clamp fixings are to the correct torque. Use special service tool 204-703 and 204-705 to torque fixings.

9. On Range Rover Sport, check torque of front and rear body mount damper fixings.

10 . If any torque-tightening is necessary, retest the vehicle on a rough road to check for other knocks.

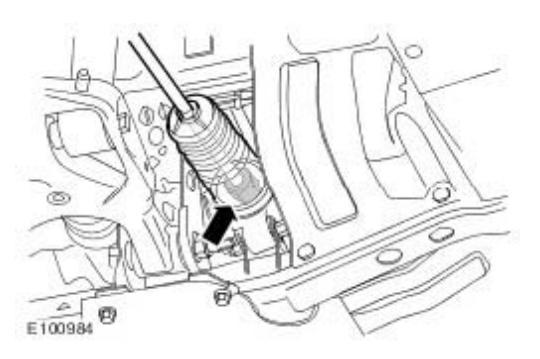
11 . **NOTE:** To isolate the steering gear design clearance, check the right-hand linkage with the steering held against the right lock stop. Likewise, check the left-hand linkage with the steering held against the left lock stop.

With the aid of another person holding the steering wheel firmly against the lock stops, firmly grasp the road wheel and apply a rocking motion. Check for any free play in the steering linkage.

1 If free play is detected, establish where the play is by compressing the boot. Feel for any . play in the inner ball joint while continuing to rock the road wheel.

2 Renew the ball joint if any free play is detected.

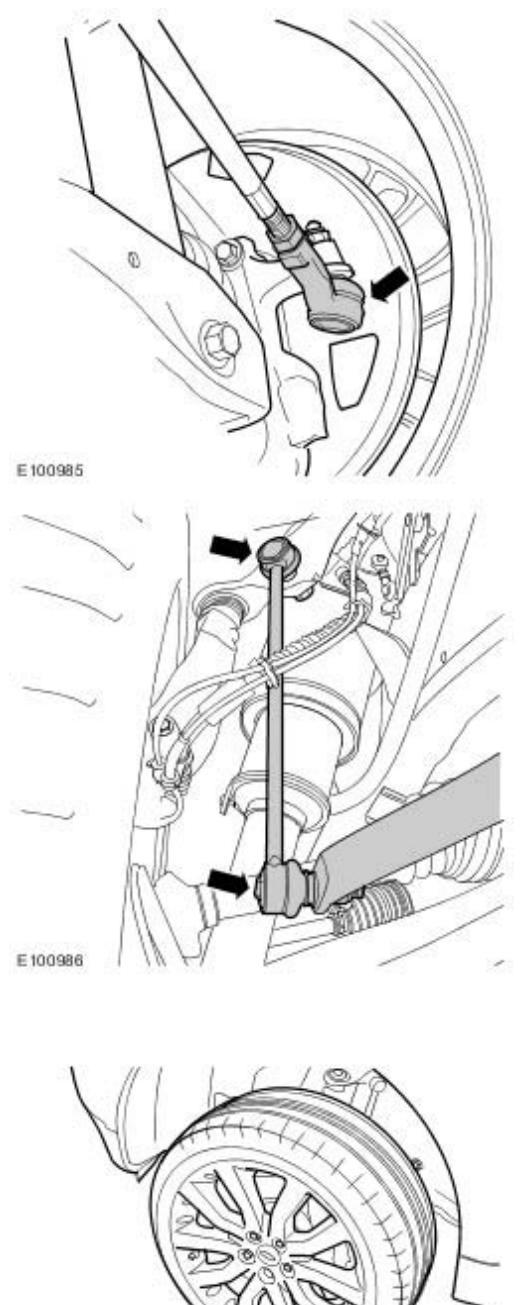
- 12 . Check the steering gear tie rod end for free play. Replace if required.
- 13 . Check the stabilizer bar links for free play at both ends. Replace if required.
- 14. Lift the vehicle so that front wheels are clear of ground/ramp to enable insertion of a suitable lever (e.g. a 1200mm long steel tube). Check the lower ball joints for free play by placing the lever between the ground/ramp and the tire, and lifting the wheel assembly with the lever. A second person will be required to check simultaneously for any ball joint lift. If free play (knock) is noted in the ball joint, replacement is required.
 15. Retest the vehicle on a rough road to check for other knocks.

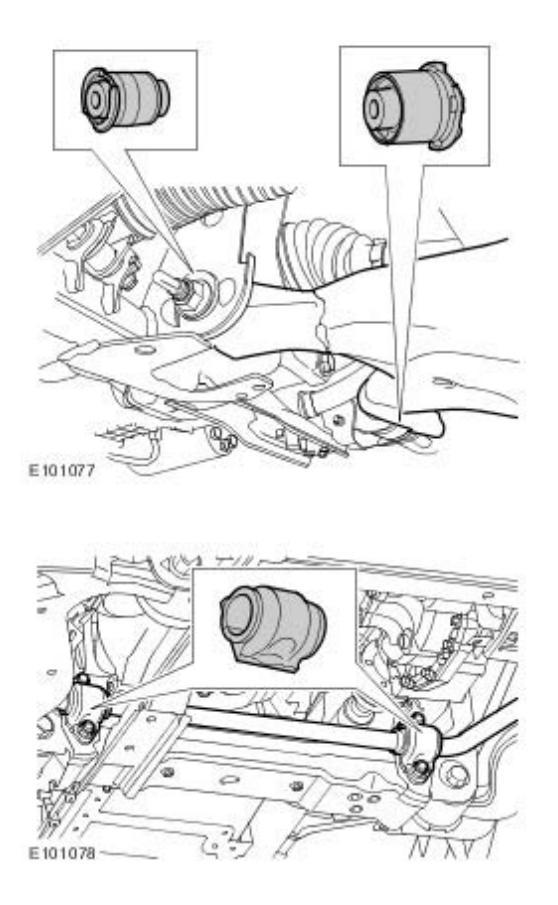
- 16 . Check the lower wishbone bushings for cracks/splits. Replace as necessary.
- 17 . Check stabilizer bar bushings for crack/splits. Replace as necessary (for vehicles with Dynamic Response, see 'Dynamic Response Vehicles Only (below).
- 18 . Retest the vehicle on rough road to check for other knocks

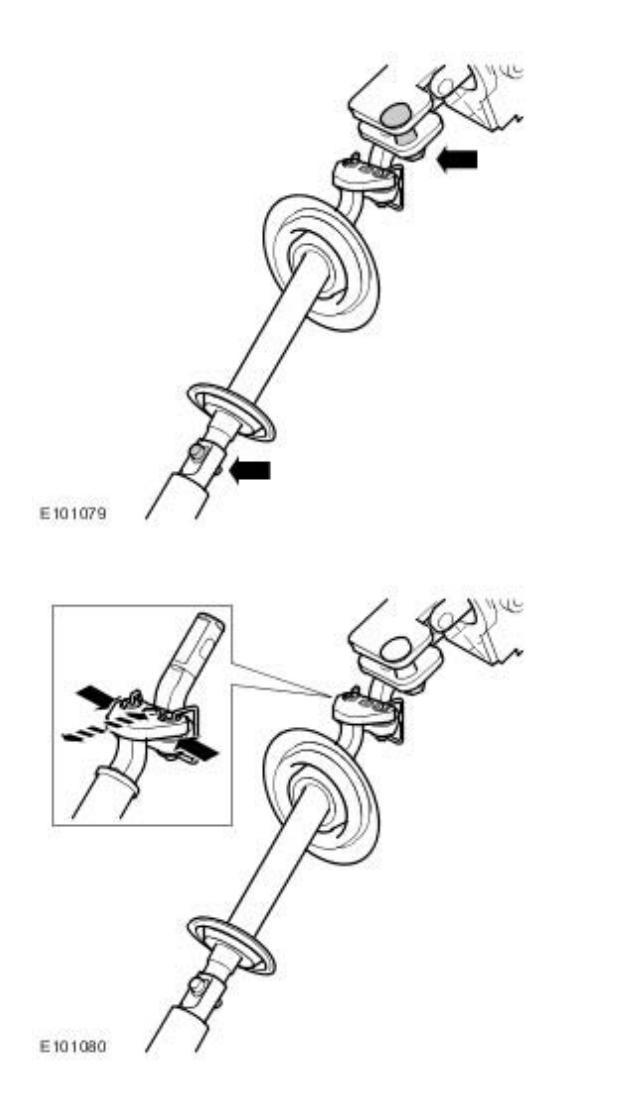
- 19. Check the steering column fixing torques. Refer to GTR for torques.
- NOTE: There is an amount of backlash in the steering system. If in doubt compare with another vehicle. Grasp shaft and move up and down.
 With the engine off, check the steering column for free play by gently rocking the steering wheel side to side.
- NOTE: A revised lower shaft has been introduced for production at assured VIN 444606/122778. Refer to bulletin LTB00097.
 If free play is evident, remove the lower fascia scuttle and check the intermediate shaft breakaway joint for free play. If relative movement can be felt across this joint change the intermediate shaft. If no relative movement can be felt across the intermediate shaft joint but relative movement is still evident, change the lower shaft.
- 22 . Retest the vehicle on rough road to check for other knocks.

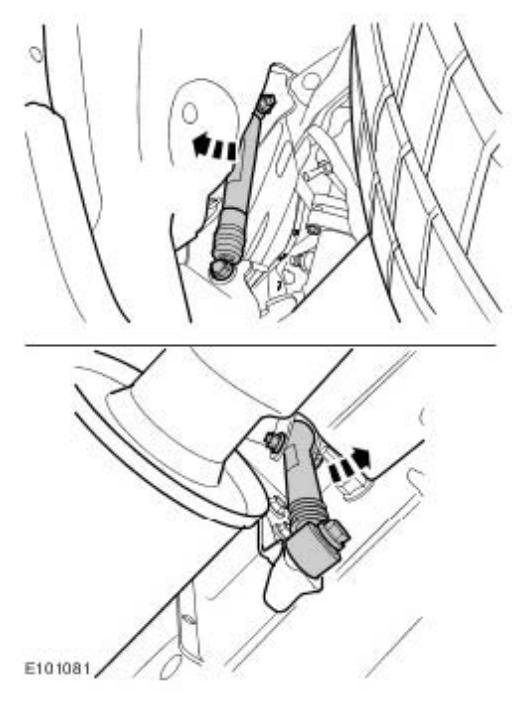
23 . Remove dampers in pairs (front, then rear) and retest vehicle to check if noise is eliminated. If so, replace dampers as appropriate.
