COMPONENT LOCATION - 1 OF 3 - FRONT SECTION - VEHICLES WITH 2 ZONE AND 4 ZONE CLIMATE CONTROL SYSTEM

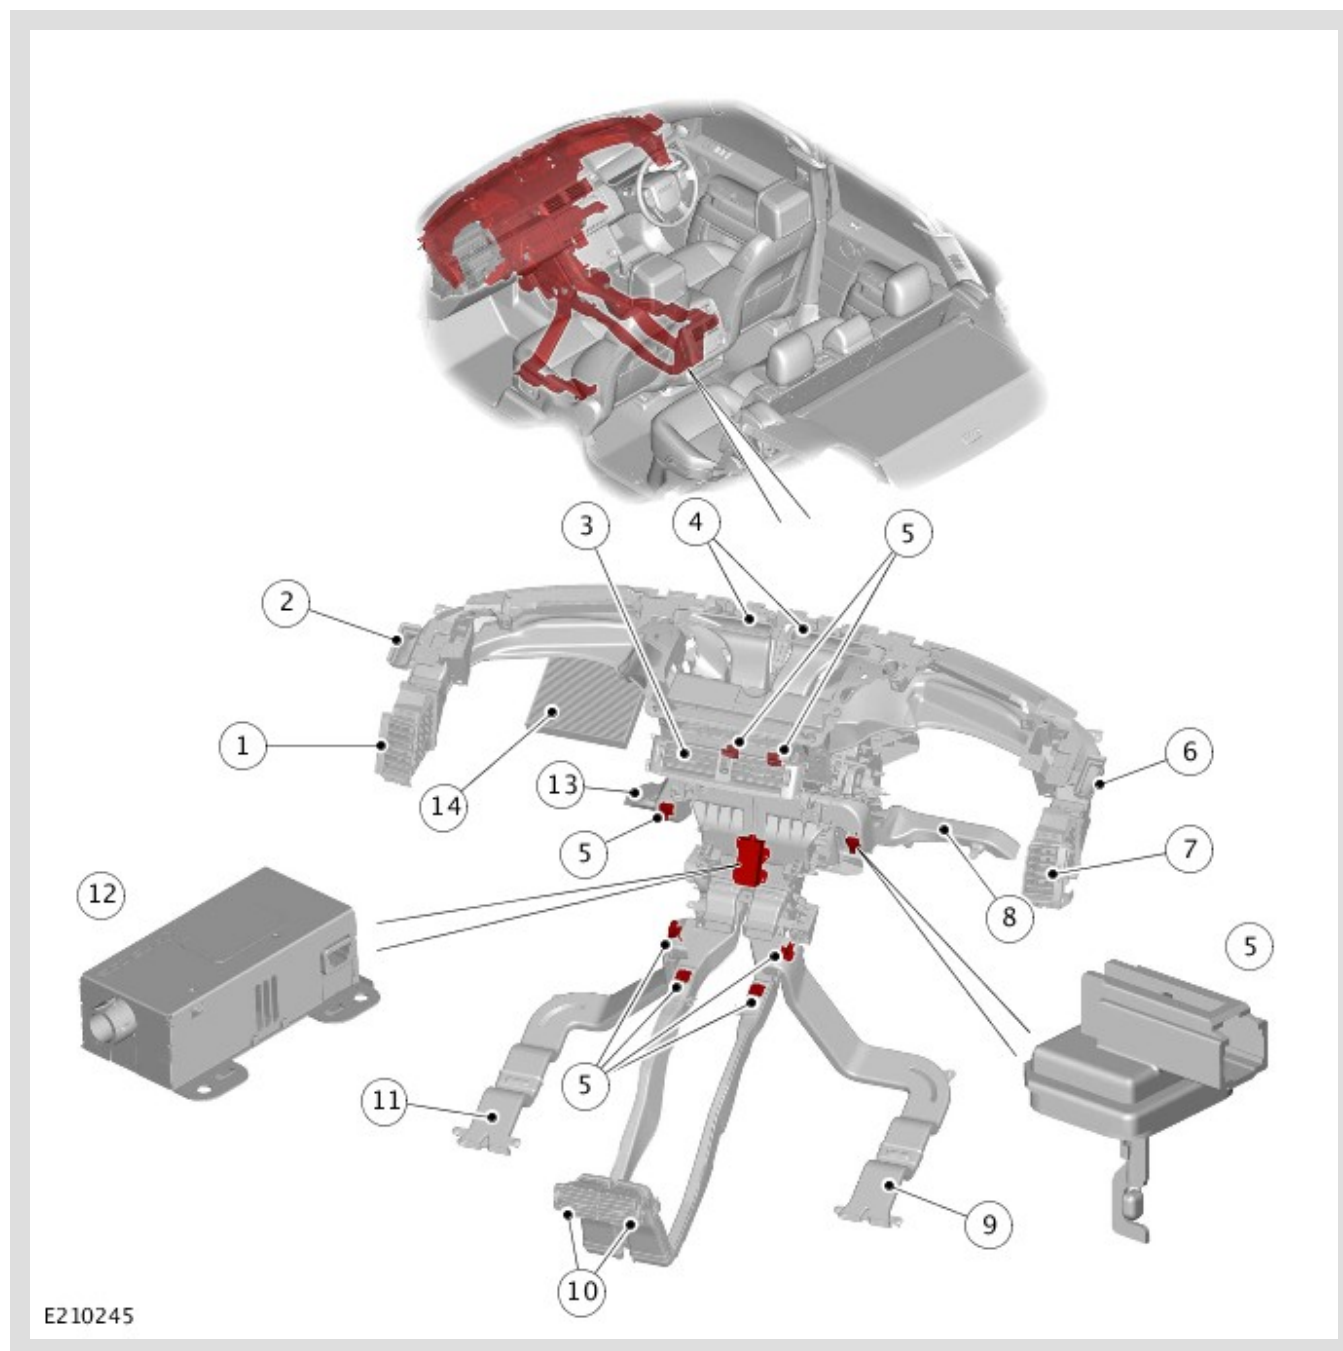
E210245

ITEM	DESCRIPTION
1	Vent - Instrument panel passenger side

ITEM	DESCRIPTION
2	Vent - Left side window
3	Vent - Instrument panel center
4	Vent - Windshield
5	Duct air temperature sensor (8 off)
6	Vent - Right side window
7	Vent - Instrument panel driver side
8	Driver footwell duct
9	Rear right footwell duct
10	Vent - Floor console - Rear
11	Rear left footwell duct
12	Air ionizer
13	Front passenger footwell duct
14	Air filter

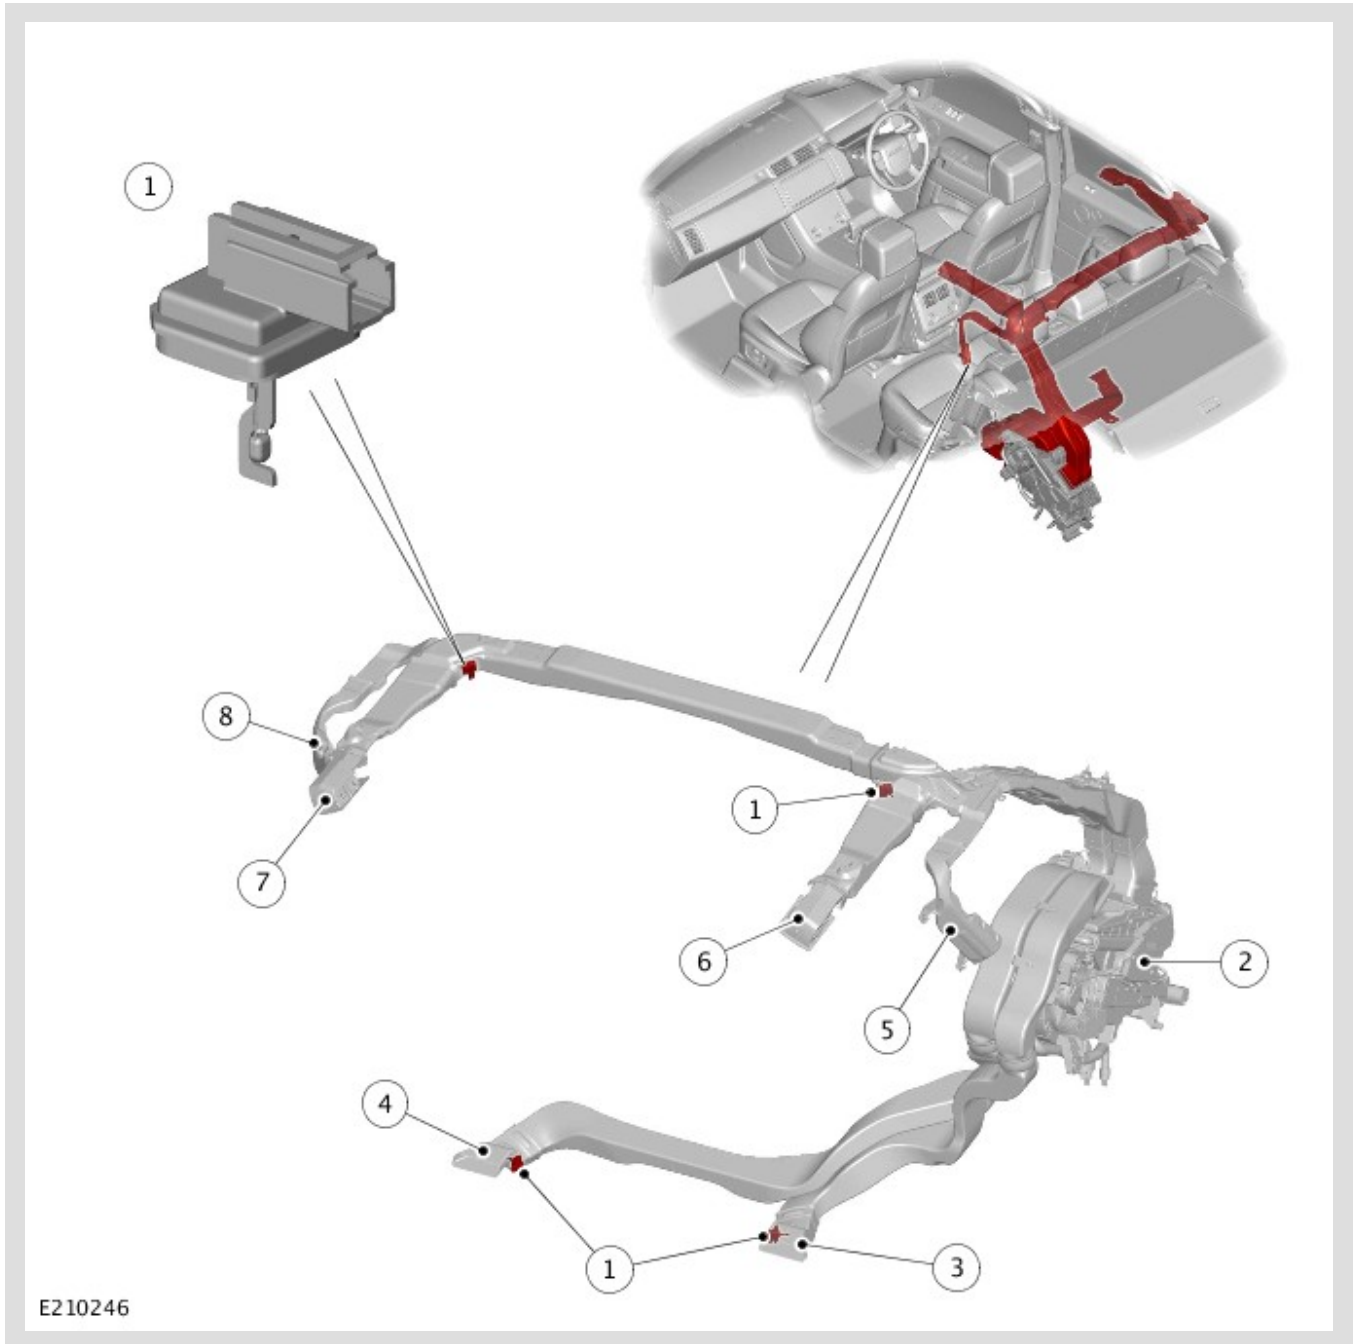
COMPONENT LOCATION - 2 OF 3 - REAR SECTION - VEHICLES EQUIPPED WITH 4 ZONE CLIMATE CONTROL SYSTEM AND WITHOUT THIRD ROW SEATS

ITEM	DESCRIPTION
1	Duct air temperature sensors (4 off)
2	Blower - Auxiliary
3	Vent - Rear left passenger seat
4	Vent - Rear right passenger seat
5	Vent - Rear left 'C' pillar
6	Vent - Rear left passenger head

ITEM	DESCRIPTION
7	Vent - Rear right passenger head
8	Vent - Rear right 'C' pillar

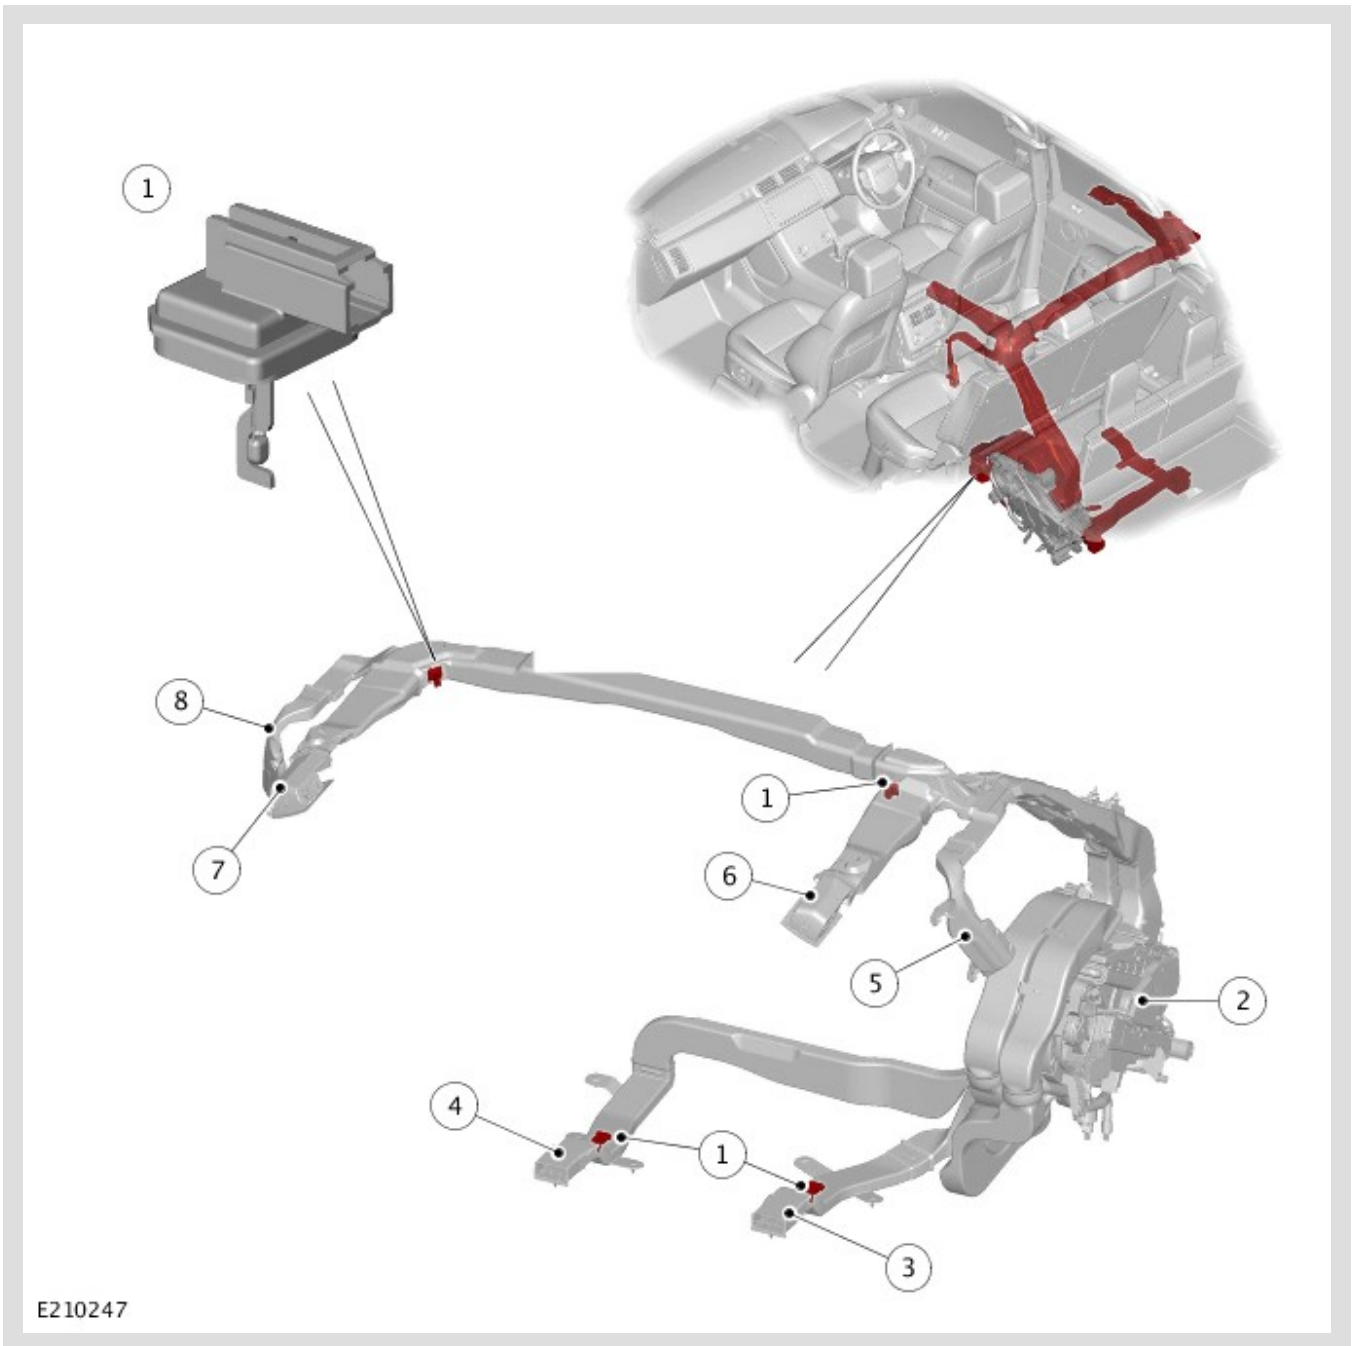
COMPONENT LOCATION - 3 OF 3 - REAR SECTION - VEHICLES EQUIPPED WITH 4 ZONE CLIMATE CONTROL SYSTEM AND WITH THIRD ROW SEATS

ITEM	DESCRIPTION
1	Duct air temperature sensors (4 off)
2	Blower - Auxiliary
3	Vent - Rear left passenger seat

ITEM	DESCRIPTION
4	Vent - Rear right passenger seat
5	Vent - Rear left 'C' pillar
6	Vent - Rear left passenger head
7	Vent - Rear right passenger head
8	Vent - Rear right 'C' pillar
