TECHNICAL BULLETIN

No: LTB00034
Issue: 2
Date: 20 MAY 2010

Passenger Compartment Water Ingress

Range Rover Sport (LS)

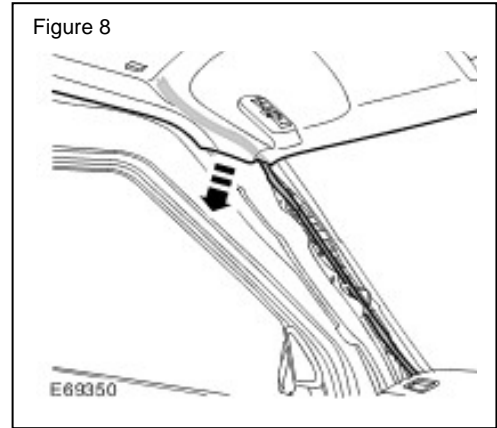
3. If the drain tube is not protruding through the hole in the body perform the following:
 - Refer to Workshop Manual (GTR) Section 418-00, *Module Communications Network* (86.70.56), and remove the CJB to gain access to the roof opening panel drain tube.
 - Connect and secure the drain tube through the hole in the body.
 - Check the valve of the roof opening panel drain tube can be fully opened. (Figure 6)
 - If the valve can not be opened, cut as required to permit full opening. (Figure 6)

4. Confirm free-flow of water by repeating the **TEST SUNROOF DRAINS** procedure for the left front drain.
5. If the concern has not been corrected, blow out drain tube with compressed air and retest.
6. If the concern has still NOT been corrected, refer to Workshop Manual (GTR) Section 501-05, *Interior Trim and Ornamentation* (76.64.15), and remove the headliner to gain access to the drain tube. (Figure 8)
7. Inspect for misrouting or kinking of the roof opening panel drain tube, paying particular attention to:
 - Collapsed elbow joints
 - Pinched tube
 - Inclined routing
8. Repair drain tube routing as necessary and retest.
9. If satisfactory test is completed install the headliner.
10. Install the CJB and the fender air intake grill.

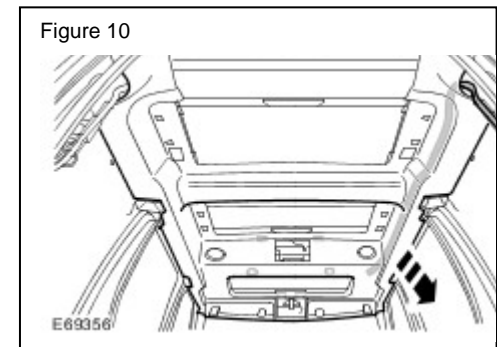
3. If the tube is not protruding perform the following:
 - Refer to Workshop Manual (GTR) Section 501-05, *Interior Trim and Ornamentation* (76.13.27), and release the right-hand side rear quarter trim panel to gain access to the roof opening panel drain tube.
 - Connect and secure the drain tube through the hole in the body.
4. Check that the valve of the drain tube can be fully opened. (Figure 5)
5. If the valve can not be opened, cut as required to permit full opening. (Figure 5)
6. Confirm free-flow of water by repeating 'Test Sunroof Drains' procedure for the right rear drain.
7. If the concern has not been corrected, blow out drain tube with compressed air and retest.
8. If the concern has still NOT been corrected refer to Workshop Manual (GTR) Section 501-05, *Interior Trim and Ornamentation* (76.64.15), and remove the headliner to gain access to the drain tube. (Figure 10)

9. Inspect for misrouting or kinking of the roof opening panel drain tube, paying particular attention to:
 - Collapsed elbow joints
 - Pinched tube
 - Inclined routing
10. Repair drain tube routing as necessary and retest.
11. If satisfactory test is completed, install the headliner.
12. Install the right-hand side rear quarter trim panel.
