Date	07/17	JLRP00100
	<b>Service Compliance Notification</b>		
Subject	Service Indicator Message and Oil Dilution		Models All

This communication has been published to provide more information about the Service Indicator Message (SIM) and Oil Dilution issues which affect 16-17MY Jaguar Land Rover vehicles.

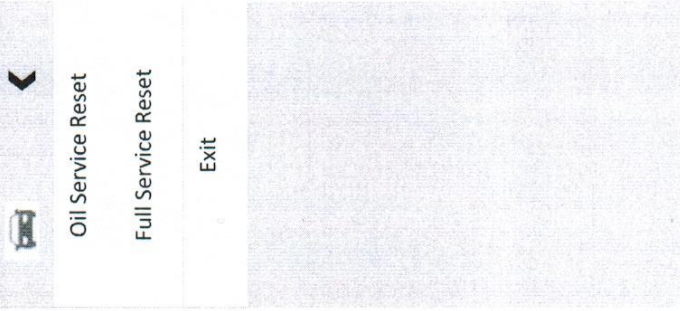
**i** Oil Service Reset: Use this option for oil and filter replacement only. This will only reset the oil dilution value.

**i** Full Service Reset: Use this option during a full service. This will reset the time and distance to next service and the oil dilution value.

Item	Value
Oil Dilution Value	6.2 %
Time to Next Service	87 days
Distance to Next Service	10128 km
