Instrument Panel Passenger Side Reinforcement (76.46.32)

Removal

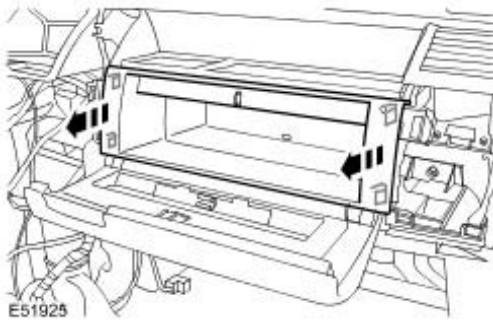
- 6 . Remove the stowage compartment tray.

*Open the stowage compartment lid.

*Release the 4 clips.
