**Range Rover Sport / Discovery 3 / 4
– LR3 / 4 & Freelander 2 / LR2
‘Seat Rock’,
Seat Track Repair Procedure**

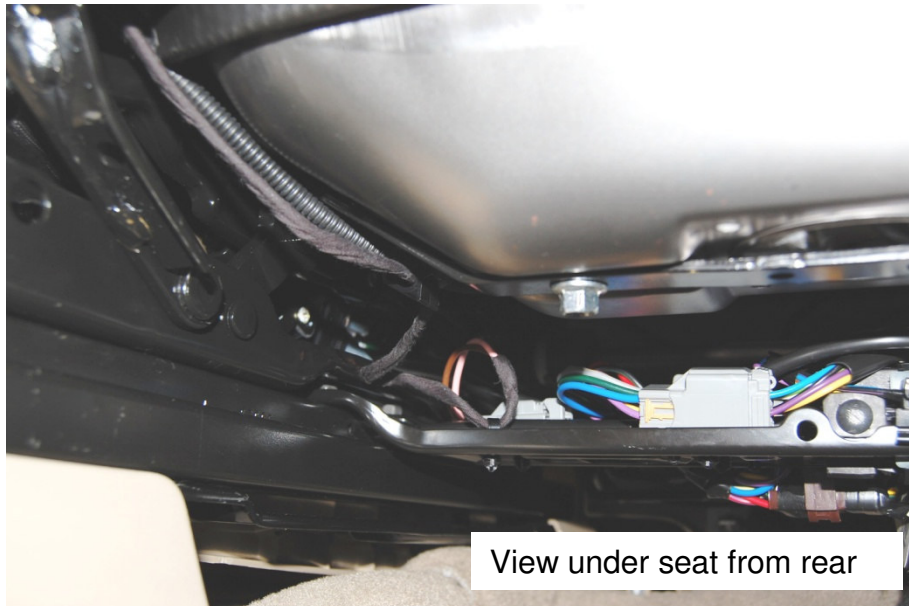
Working from the back of the seat:

- 2) If necessary, remove the connector (Arrow A) from the seat track motor bracket to gain access to the longer (Arrow B). Note:-This is the Left-hand of the two seat track drive cables when sitting in the seat.
- 3) Remove this cable end from the seat track motor, keeping the other end engaged into the track drive gear assembly. Note the rotational position of the cable end – this is important for re-assembly

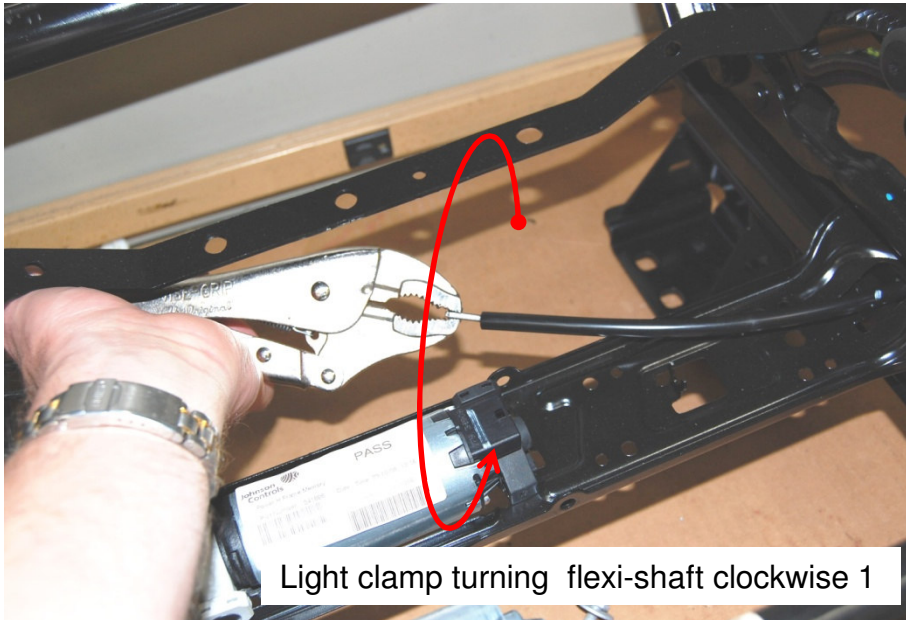
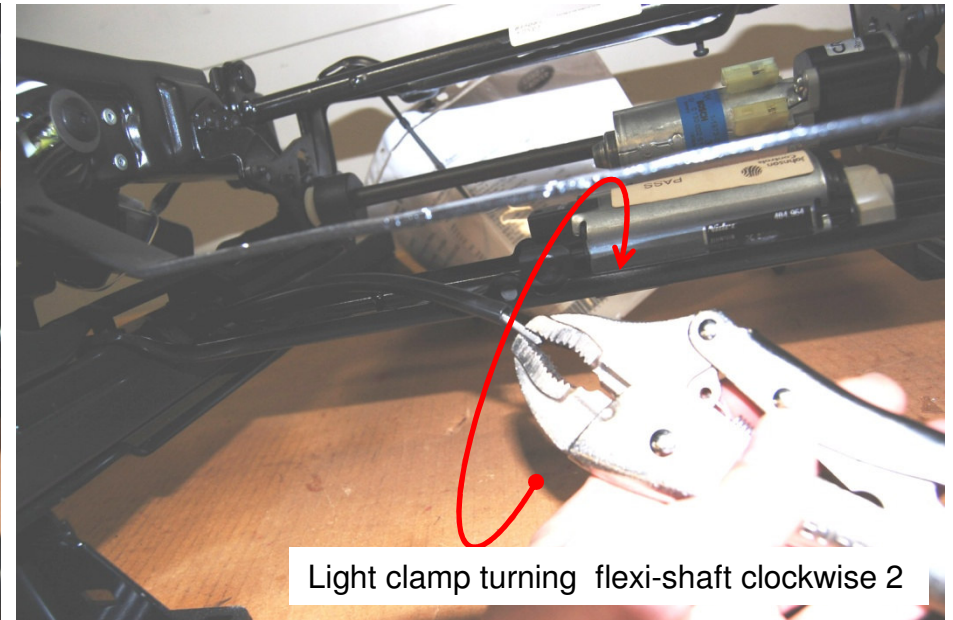
- 4) Connect a suitable pair of locking pliers to the end of the drive cable. *Ensure a light grip is used as cable end is easily damaged.*
- 5) Turn the drive cable **Clockwise 13 Full rotations.**

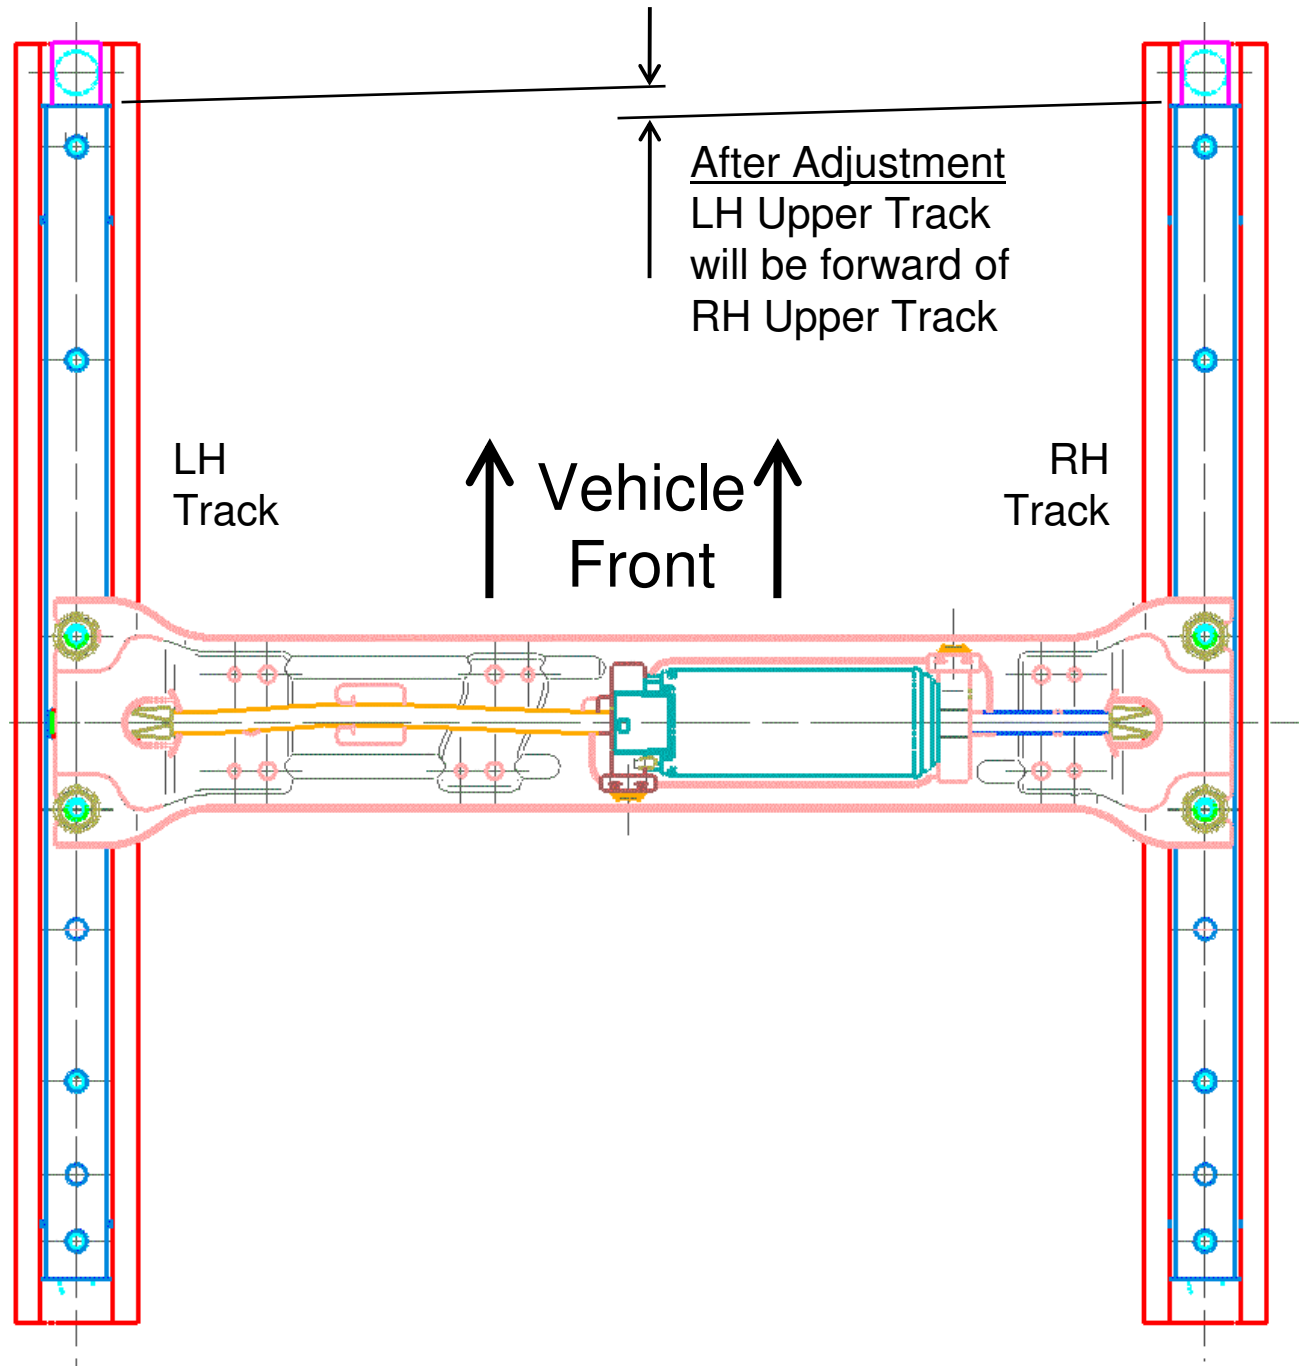
Prior to adjustment, track uppers will be aligned to $\pm 0.5\text{mm}$.

Each full revolution of the flexi-shaft will generate a 0.4mm forward movement of the LH track upper.

NEVER run the motor with a flexi-shaft removed. Seat structural damage may occur.
