Reference SSM33946

Models Discovery 3
Range Rover Sport

Title Discovery 3 /LR3 & Range Rover Sport Steering Wheel
Peel/Wrinkle

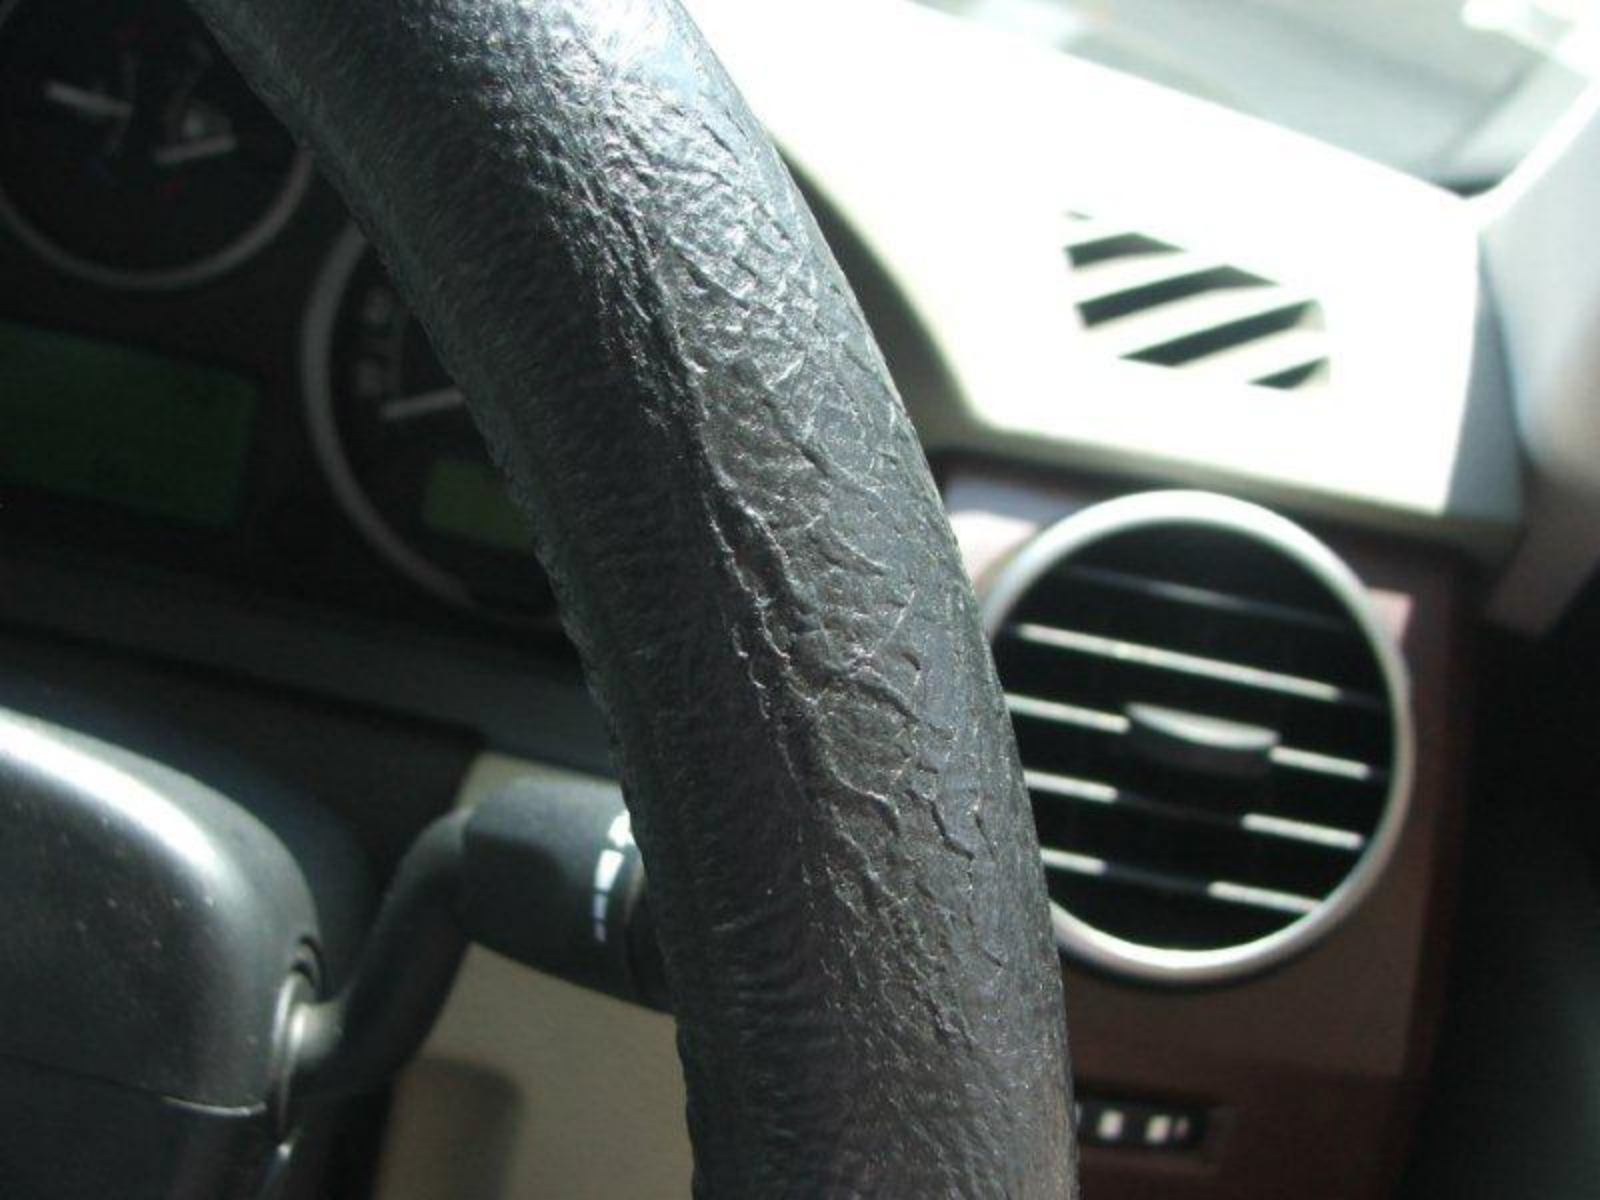
[Steering_wheel_blister.jpg](#)

Potential concern: Discovery 3 / LR3 and Range Rover Sport customers in hot climate markets only, may report the Steering wheel leather cover becoming sticky, wrinkly and / or peeling off. The attached picture displays the condition.

Action: A limited number of modified condition replacement steering wheels are available through Caterpillar and must be replaced only on a 'fix on complaint' basis for this concern. Please do not stockpile parts.

The Replacement Steering wheel Part numbers are:
LR 006967 - No Cut out
LR 006968 - L/H Cut out for 'Push to talk Switch'
LR 006969 - L/H & R/H Cut out for 'Push to talk' Switch & 'Phone End call' Switch'
